# Manhole Inspection Summary

Manhole # S350\_\_054MH

Insp Date: **1/24/08 11:41 AM**

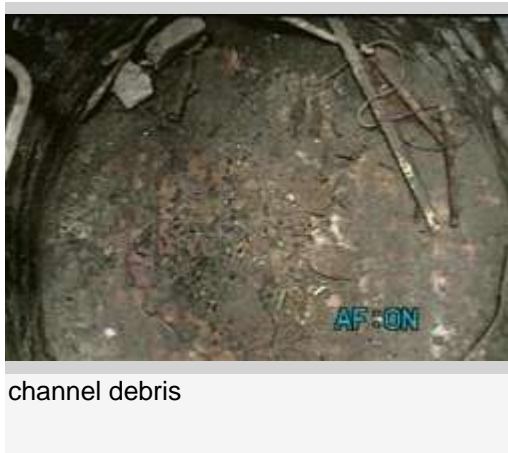
Miscellaneous

channel debris

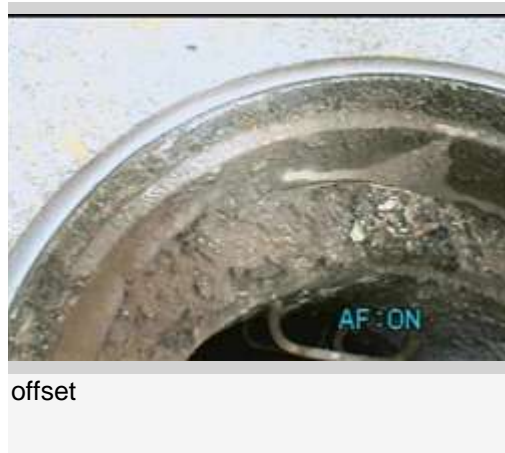
Defect 1

Offset: **4** (in.)

offset

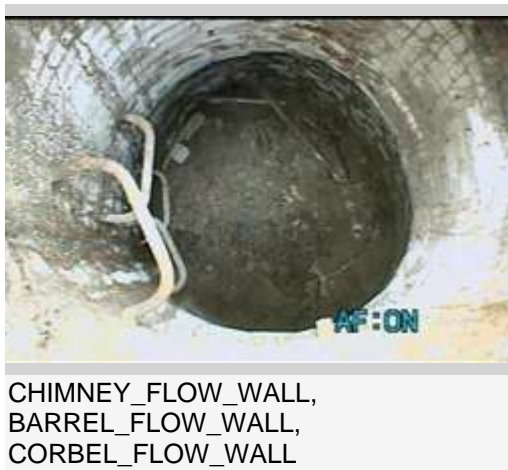
Defect 2

Infiltration: ☐ None ☐ Joint ☐ Cracks ☐ Mortar ☐ Roots ☒ **Wall**

CHIMNEY\_FLOW\_WALL,  
BARREL\_FLOW\_WALL,  
CORBEL\_FLOW\_WALL

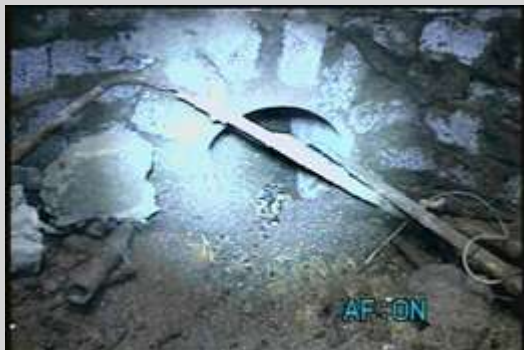
12 O'Clock Outflow

8 in. Circular Gravity Sewer  
Pipe Out @ 12 O'Clock
